Multidisciplinary Studies, Crossreading and Transversal Use of Thermography: The Castle of Monzón (Huesca) as a case study

Camilla Mileto^a, Fernando Vegas^b, José Luis Lerma^c

Abstract

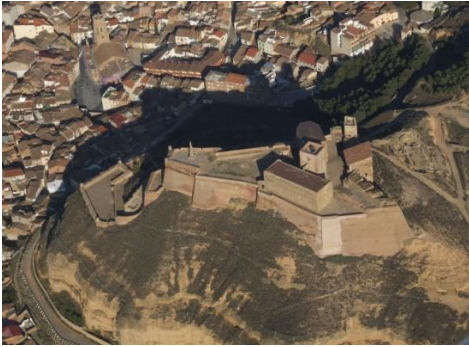
Fig. 3 - South-west aerial view of the castle where the medieval buildings on the upper plateau and the 18th and 19th bastions can be seen

These adaptations continued throughout the 19th century, although these were mainly minor additions, repairs and improvements to the installations. However, following the War of Independence (1808-1814), the castle of Monzón progressively lost its strategic value, although it recovered its importance during the fraught period of 1820-1823, as well as during the four Carlist Wars. After this last episode, the castle of Monzón gradually decayed until 1933, when the Ministry of Defence sold the fortress to the Treasury. In 1949, the castle was classified as a National Monument (fig. 3).

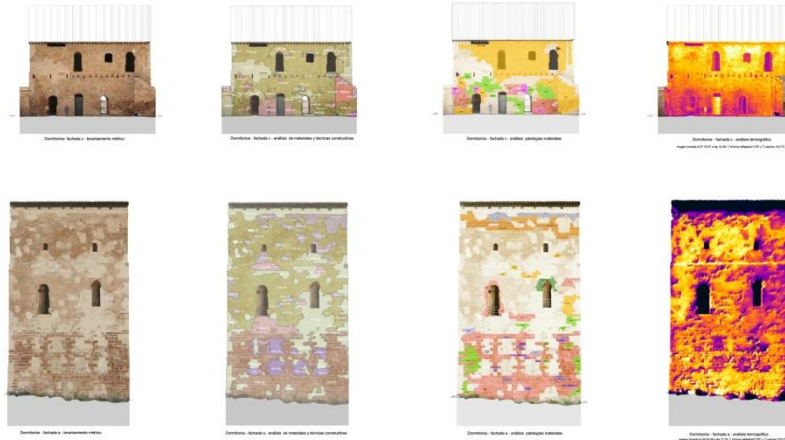
Fig. 5 - Synoptic plans: a) photogrammetric survey; b) material study; c) pathologies; d) thermography

The final organization of the thermographic documentation allowed us to produce rectified thermophotographs of some of the most outstanding façades within the synoptic plans, aiming to give a global vision of the materials and pathologies of these façades, emphasized and enhanced by the thermographic image (fig. 5). Based on the general observation of the façades it can be stated that thermography allows a clear identification and hence precise positioning of different material densities, as well as porosity, critical moisture content, specific heat capacity and thermal conductivity, and, thus of material decay.

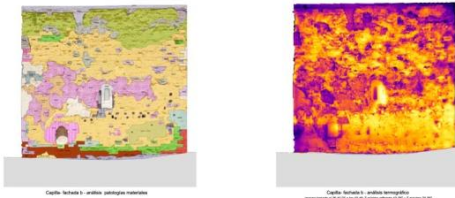
Fig. 6 - South façade of the Chapel where the different materials can be clearly distinguished: Stone in yellow, brick in magenta and purple, and gypsum renderings in orange.

More compact materials appear darker, i.e. colder, while more porous or more disaggregated materials appear lighter, i.e., warmer. Thus, in the rectified thermophotographs ceramic materials stand out more than stone, usually represented in lighter colours. Although this phenomenon is evident in all the façades, it is even more so in the south façade of the Chapel (fig. 6).

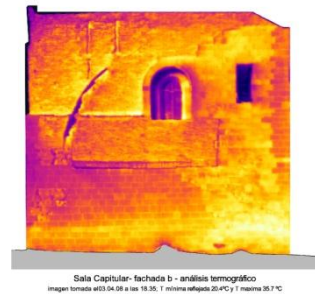
Fig. 7 - South façade of the Knights' House. There is a clear difference between the stone ashlar and the mortar and the different interventions made to date, such as the substitution of the ashlars in the east corner

In some cases, the difference in physical and thermal properties between materials, as well as the consequent thermal inertia, allows the ashlars to be clearly distinguished from the mortar joints. The round stones, also denser, always appear much darker than the stone ashlars. This phenomenon is also clearly seen in façades as characteristic as the lower part of the south façade of the Dormitories, the façade of

the Donjon tower or the south façade of the Knights' House (fig. 7).
